V.I. Inspections

1813 72nd Ct SE

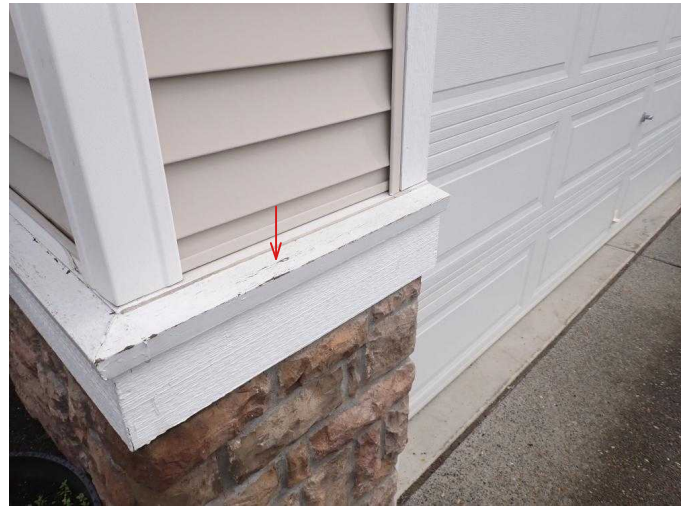
#2 Minor paint peeling in sections of wood trim work.

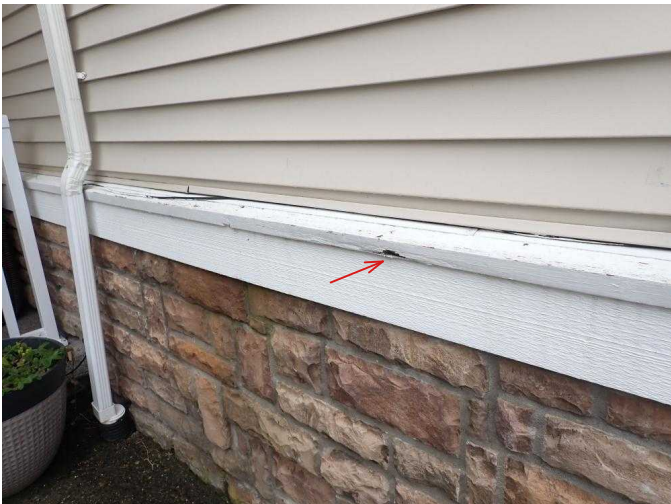
#3 Minor rot occurring in W wood trim on attached garage exterior.

2. ☐☐☐☒☐ **Trim:** Vinyl, Wood. Minor rot occurring in W wood trim on attached garage exterior.
Rot occurring in attached garage door trim where in contact with cement.
Minor paint peeling in wood trim system, should be prepped and resealed against moisture intrusion.
Paint is well worn on upper sides of knee braces, should be resealed against moisture intrusion.
Recommend qualified contractor evaluate and estimate repairs.
Ends of knee brace trim work, protruding into weather from soffit areas, need to be maintained against moisture intrusion. Either paint needs to be maintained and/or metal flashing installed to prevent water intrusion into wood product.

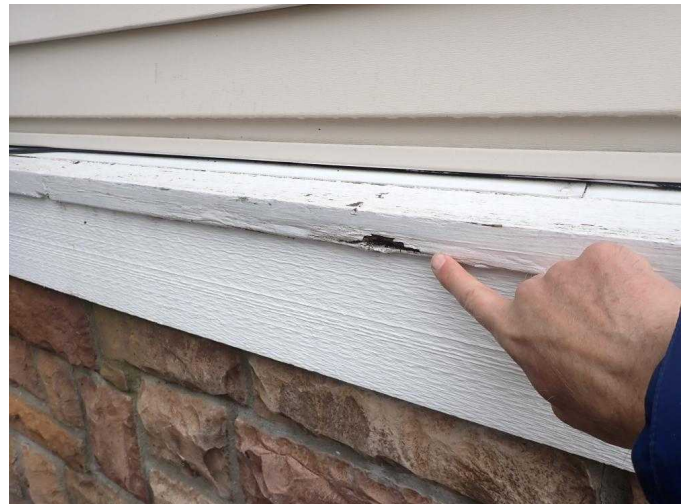
#4 Minor rot occurring in W wood trim on attached garage exterior.

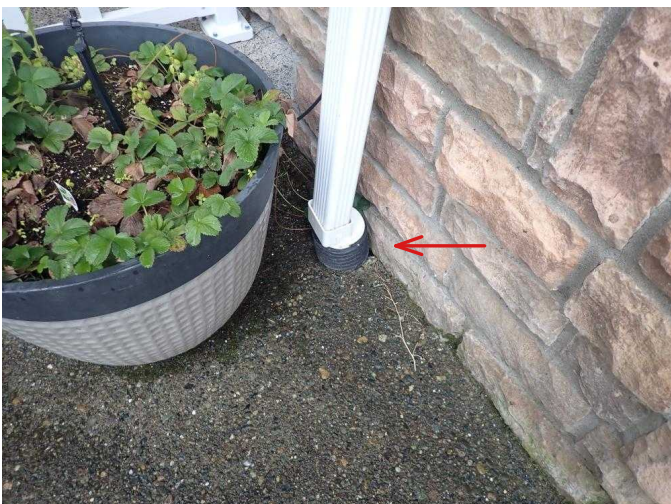
#5 Plastic corrugated pipe used as leader system has a higher potential for clogging, will need to be maintained.

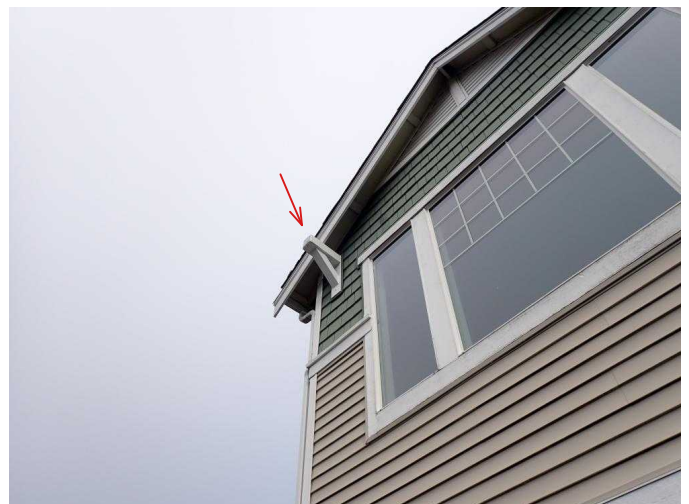
#6 Ends of knee brace trim work, protruding into weather from soffit areas.

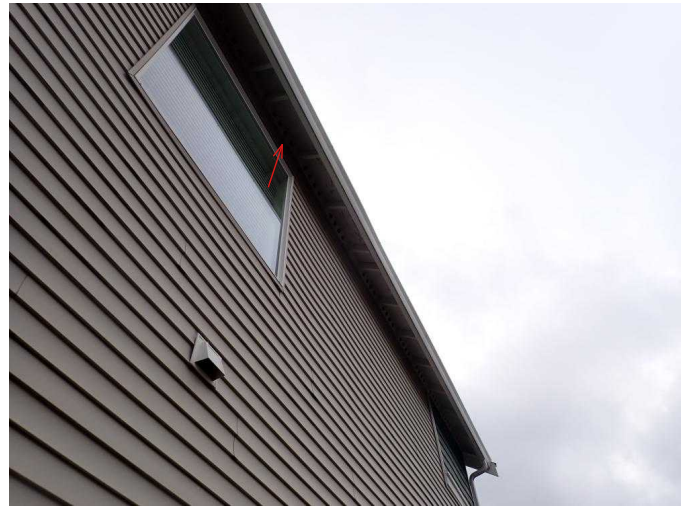
#8 Paint peeling in upper W soffit material.

4. ☒☐☐☐☐ **Soffits:** Wood. Minor paint peeling in W soffits, should be prepped and resealed against moisture intrusion.
5. ☒☐☐☐☐ **Door Bell:** Hard wired.

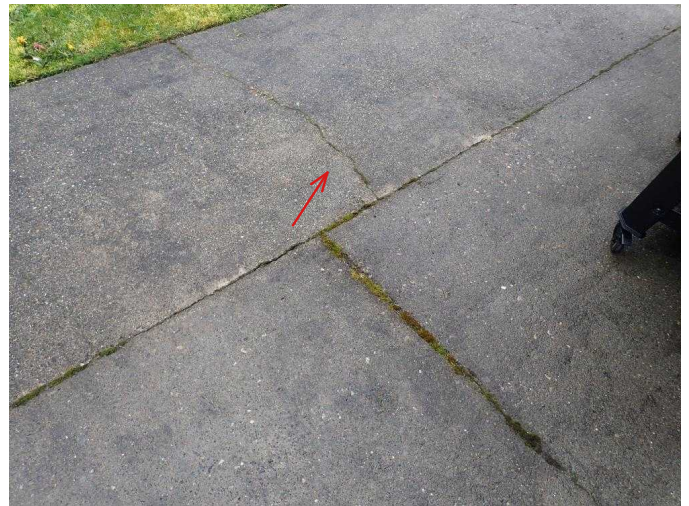
#10 Minor cracks in N patio surface are present with minor settling.

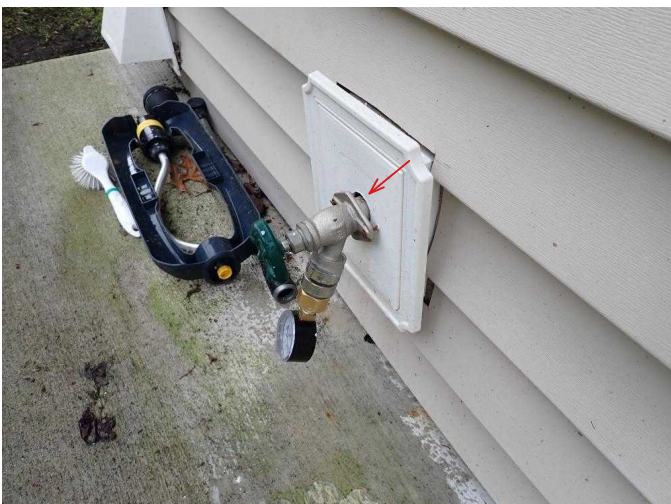
#11 N hose bib is loose on install, needs tightening.

10. ☒☐☐☐☐ **Exterior Lighting:** Surface mount.
11. ☒☐☐☐☐ **Exterior Electric Outlets:** 120 GFCI.
12. ☒☐☐☐☐ **Hose Bibs:** Gate. N hose bib is loose on install, needs tightening.
Remember to protect hose bibs against freezing in winter months.

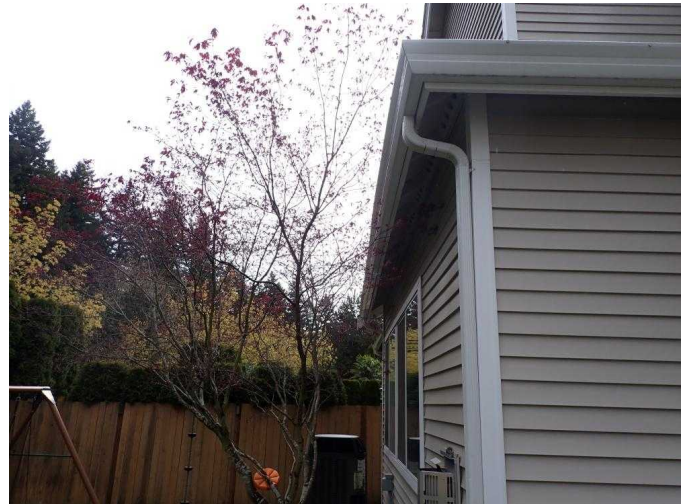
#14 Tree in contact with lower N roof needs to be trimmed back.

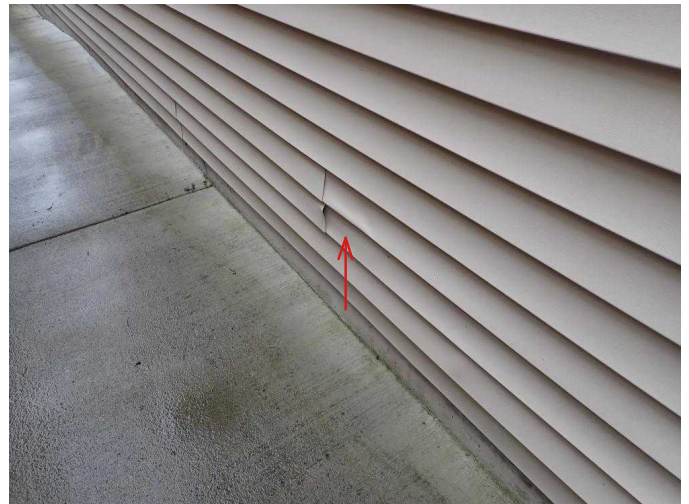
#16 Minor buckling in lower E siding.

1. ☒☐☐☐☐ **Type:** Vinyl siding, Stone veneer. Lower vinyl J-track on E side of front porch door is bent.
Minor buckling in lower E siding.
Recommend qualified contractor evaluate and estimate repairs.

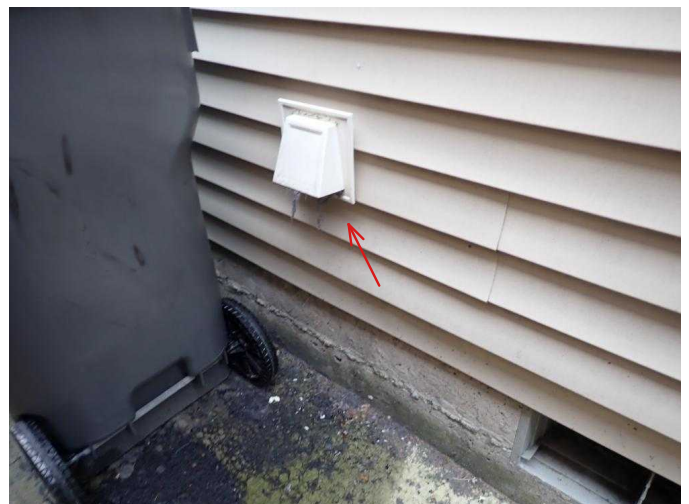
#18 Dryer vent needs to be cleaned.

13. ☒ ☐ ☐ ☐ ☐ Washer and Dryer Electrical: 120-240 VAC.
14. ☐ ☐ ☐ ☒ ☐ Dryer Vent: Rigid metal. Dryer vent needs to be cleaned.
Recommend yearly cleaning of dryer vent.

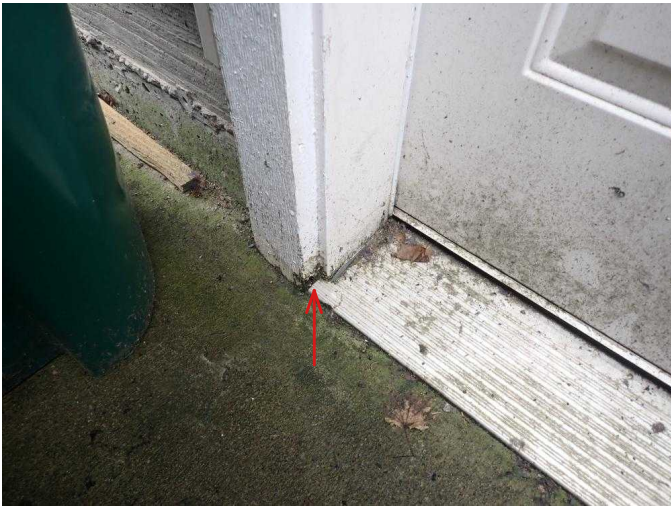
#19 Rot occurring in attached garage door trim where in contact with cement.

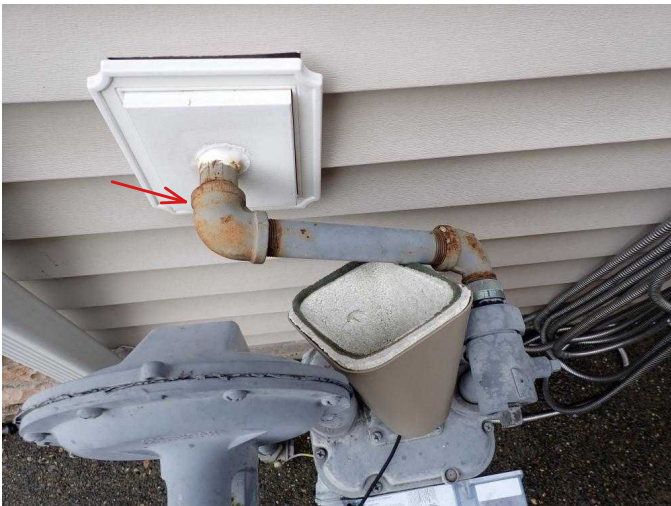
#21 Exterior sections of gas lines are rusty.

8. ☒ ☐ ☐ ☐ ☐ Vent Pipes: ABS.
9. ☒ ☐ ☐ ☐ ☐ Gas Service Lines: Cast iron, flexible gas pipe. Minor rust on exterior section of gas supply pipe, should be prepped and painted to extend life.

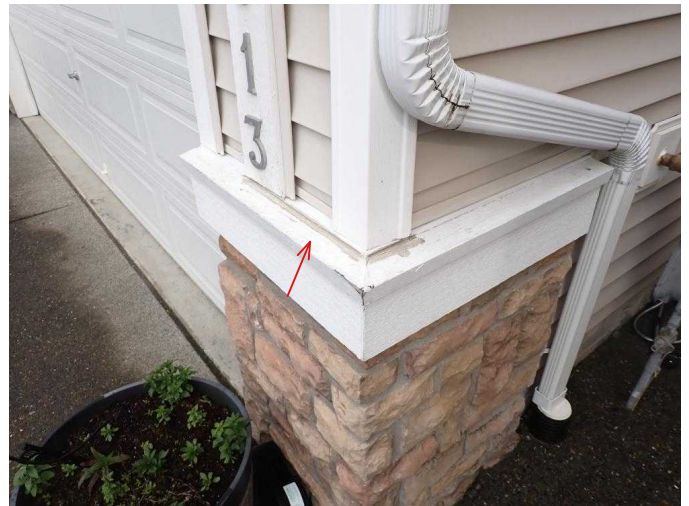
#22 Minor paint peeling in wood trim system.

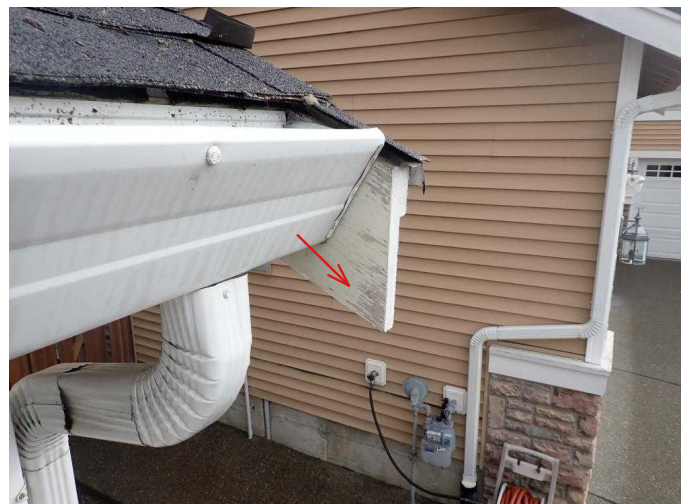
#24 Minor paint peeling in lower fascia tails.

3. ☒☐☐☐☐ **Fascia:** Wood. Minor paint peeling in lower fascia tails, need prepped and resealed against moisture intrusion.
A qualified contractor is recommended to evaluate and estimate cost.

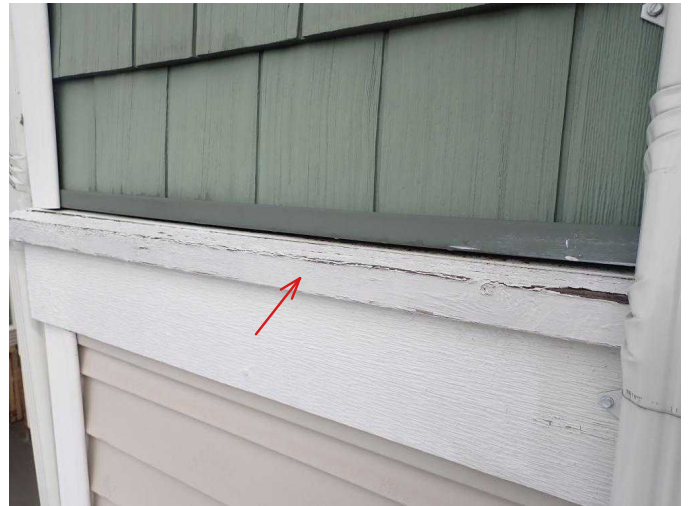
#26 Minor paint peeling in wood trim system.

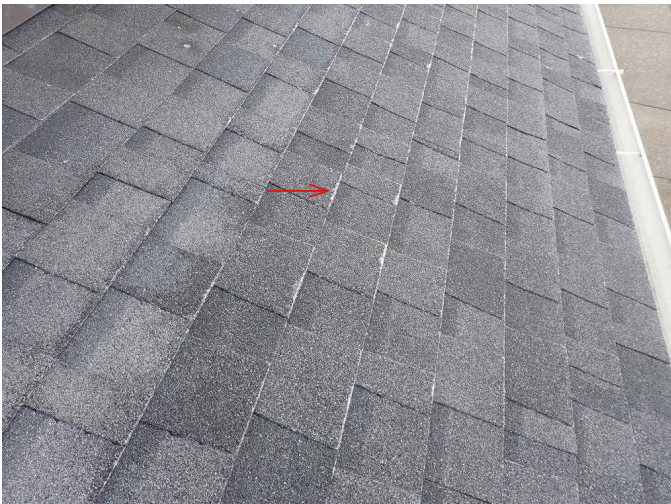
#27 Roof is moderately worn with small sections of fiberglass mesh exposed.

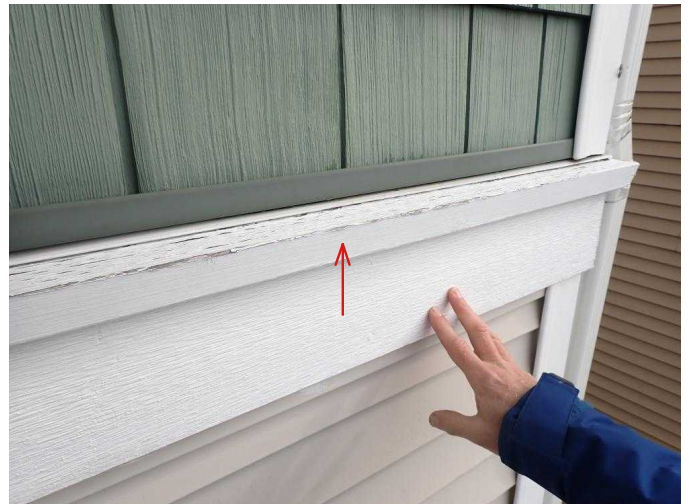
#28 Minor paint peeling in wood trim system.

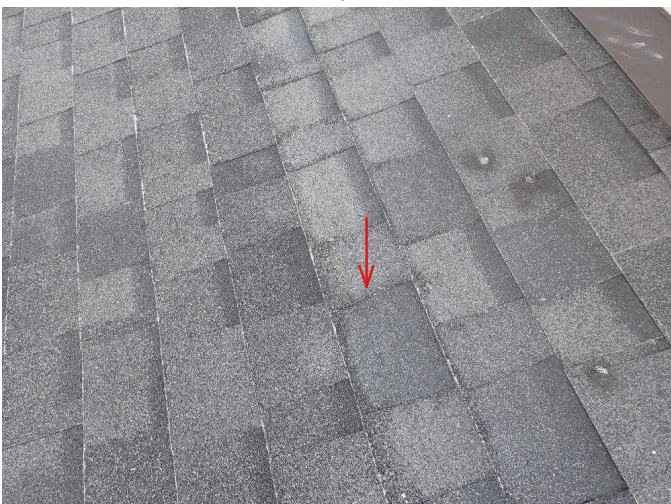
#29 Roof is moderately worn with small sections of fiberglass mesh exposed.

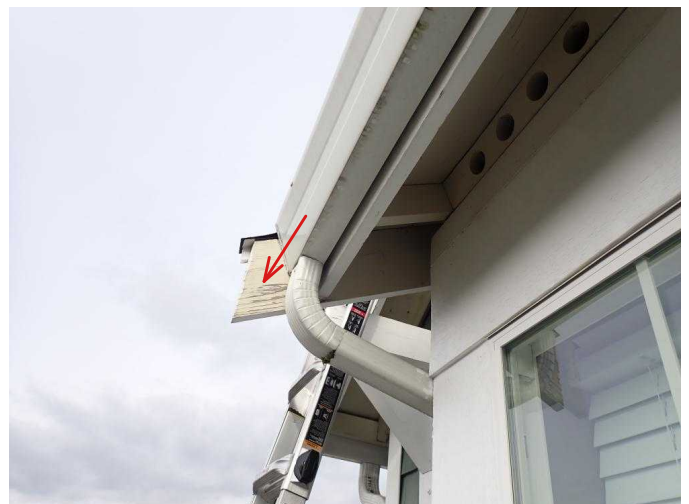
#30 Paint peeling in lower fascia tails.

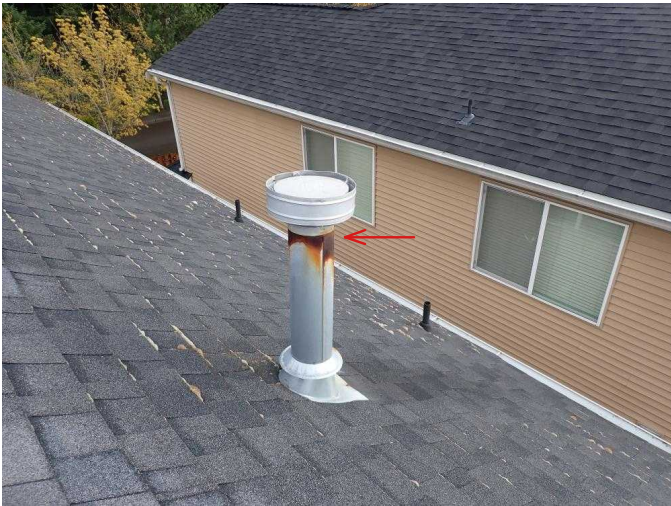
#31 Exterior section of furnace flue starting to rust and will need to be replaced in next 5 years.

10. ☒☐☐☐☐ **Distribution:** Insulated duct system.
11. ☒☐☐☐☐ **Circulator:** Fan.
12. ☒☐☐☐☐ **Draft Control:** Automatic.
13. ☐☐☐☒☐ **Flue Pipe:** Double wall. Exterior section of flue starting to rust and will need to be replaced in next 5 years.

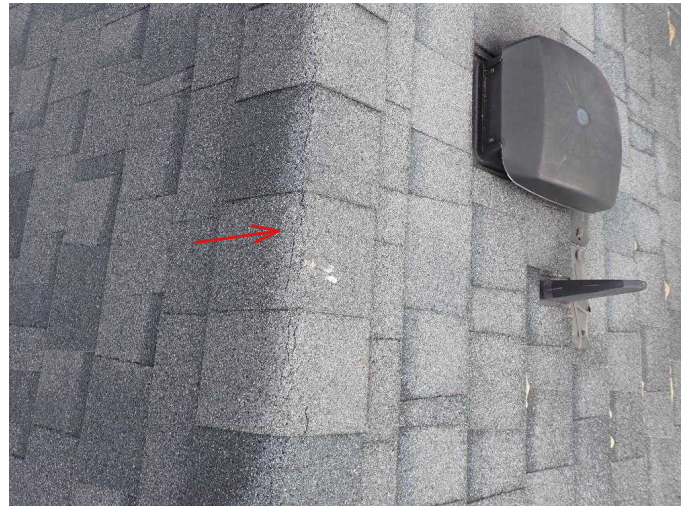
#32 Minor cracking in ridge cap material.

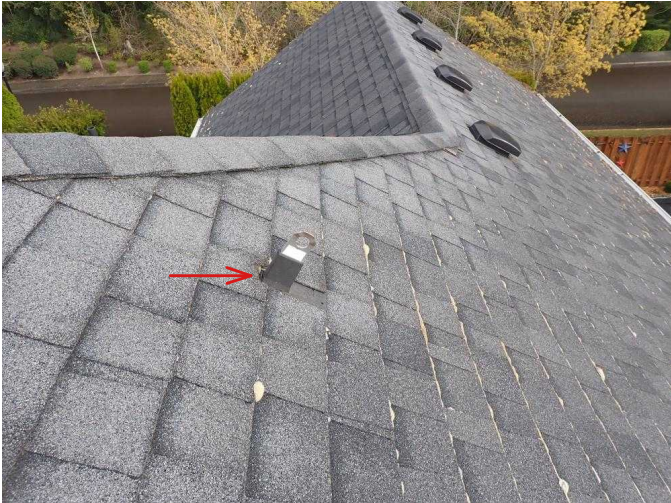
#33 NE safety anchor is missing weather cover on roof.

7. ☒ ☐ ☐ ☐ ☐ Valleys: Preformed metal.
8. ☐ ☐ ☐ ☒ ☐ Safety Anchor: Roof mount. NE safety anchor is missing weather cover, moisture intrusion spot, weather cover needs be replaced.
Recommend qualified roofer replace missing weather cover.

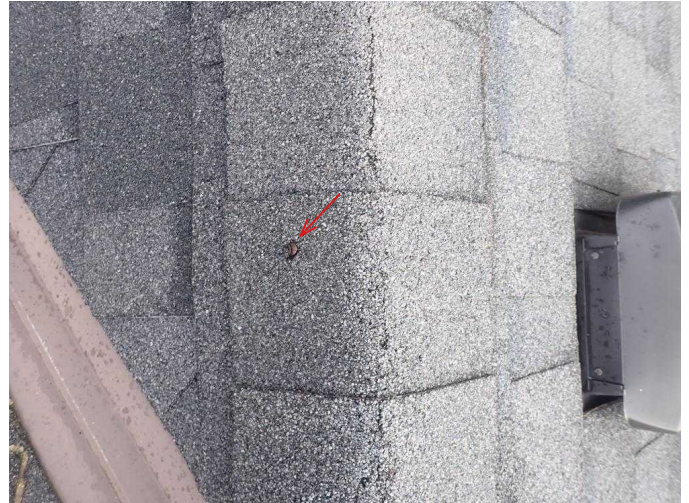
#34 Nail pop in NE ridge cap shingle.

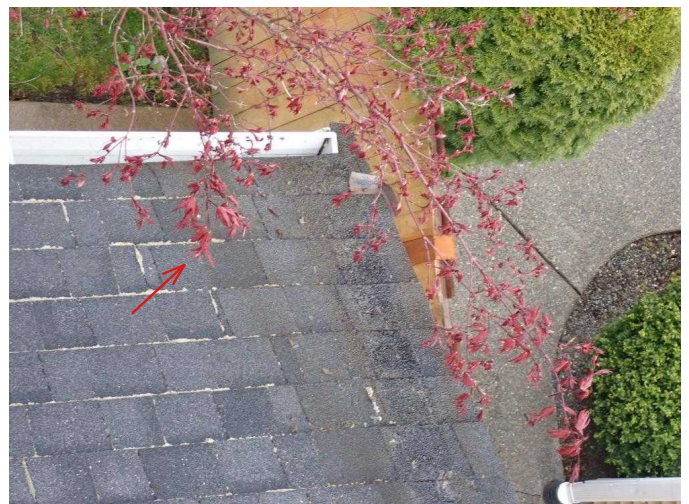
#36 Tree in contact with lower N roof needs to be trimmed back.

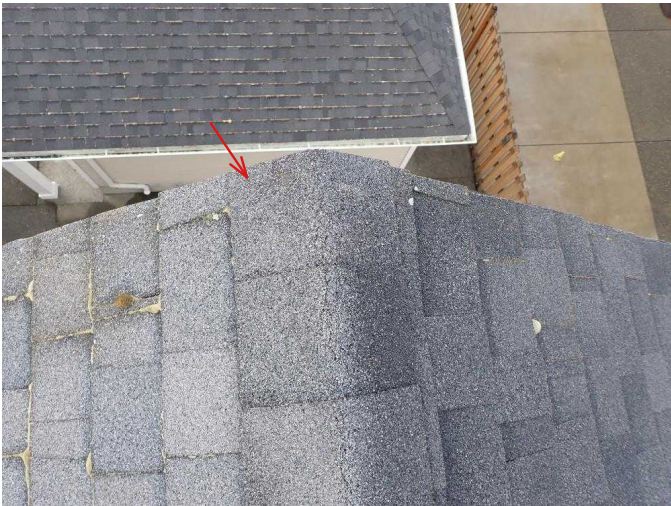
#37 Moderate wear in roof system.

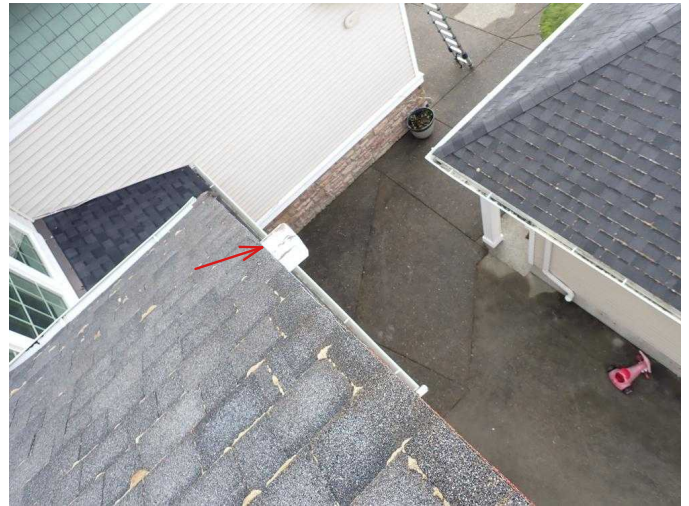
#38 Paint is well worn on upper sides of knee braces.

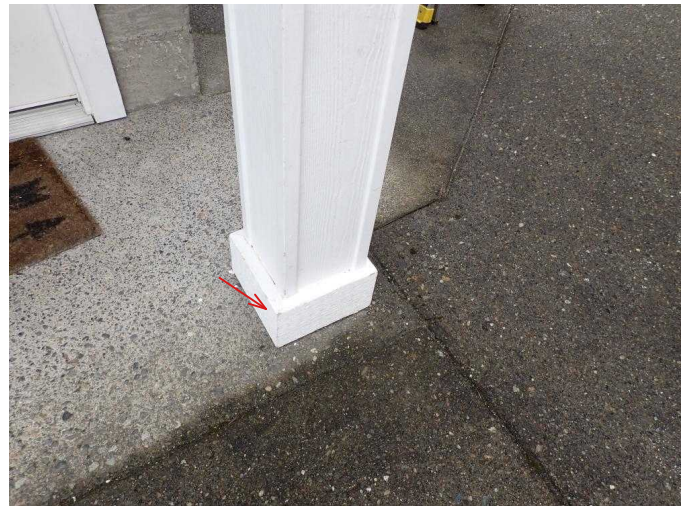
#40 Minor paint peeling in wood trim work.

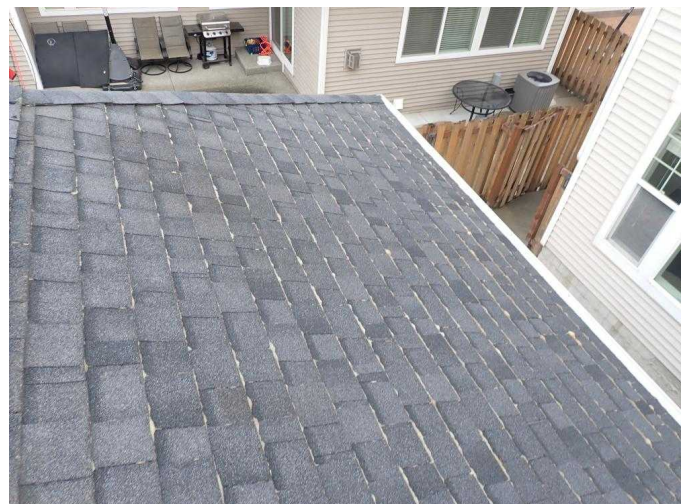
#42 Minor moss build up on roof surface, moss appears to have been treated.

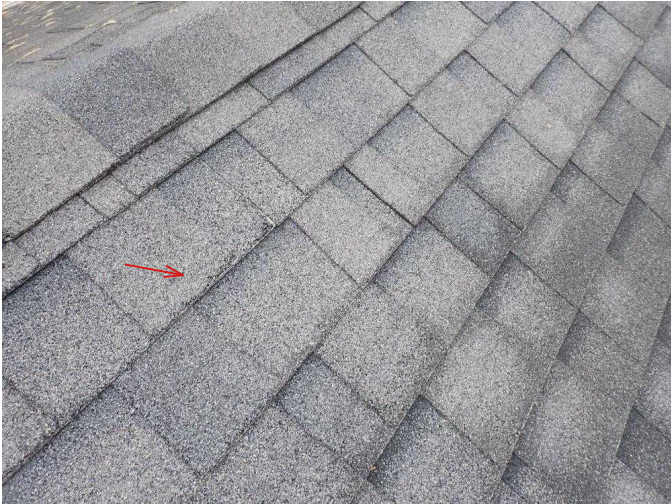
#43 Roof is moderately worn with small sections of fiberglass mesh exposed.

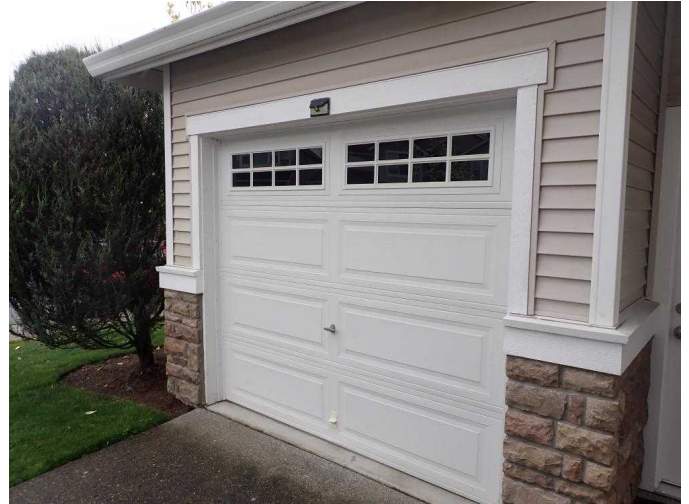
#44 Auto door is currently not usable.

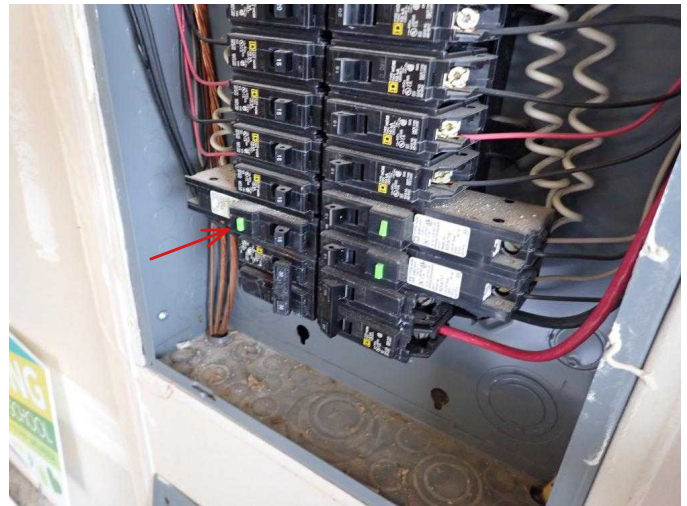
#52 Recommend branch feeder type AFCI breakers be updated to combination type in main panel.

10. ☒☐☐☐☐ Manufacturer: Square D.
11. Maximum Capacity: 200 Amps.
12. ☒☐☐☐☐ Main Breaker Size: 200 Amps.
13. ☒☐☐☐☐ Breakers: Copper and Aluminum.
14. ☒☐☐☐☐ AFCI: 120 VAC. Recommend branch feeder type AFCI breakers be updated to combination type AFCI breakers to provide a wider range of arc fault protection.

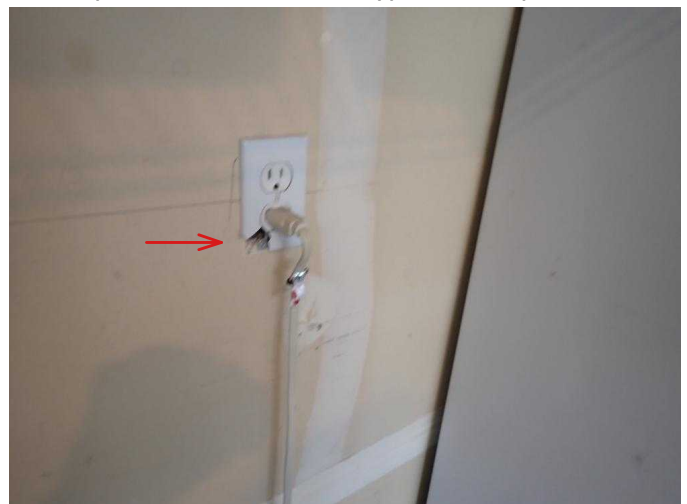
#54 Outlet cover plate broken in garage, should be replaced.

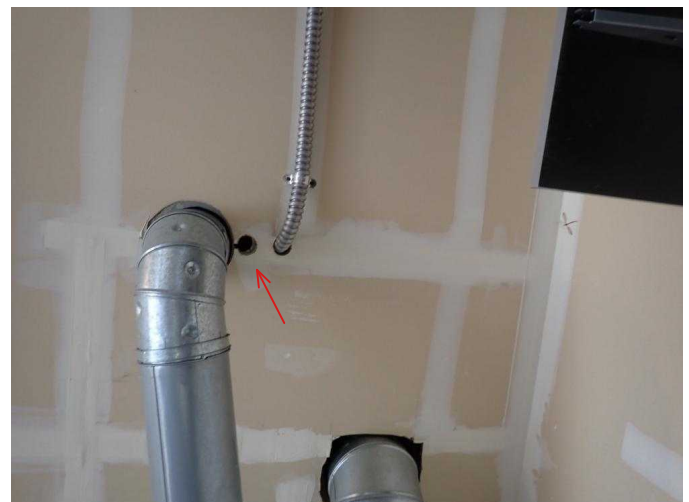
#60 All open holes and gaps in ceiling need to be sealed against fire intrusion if a vehicle is to be parked in the garage.

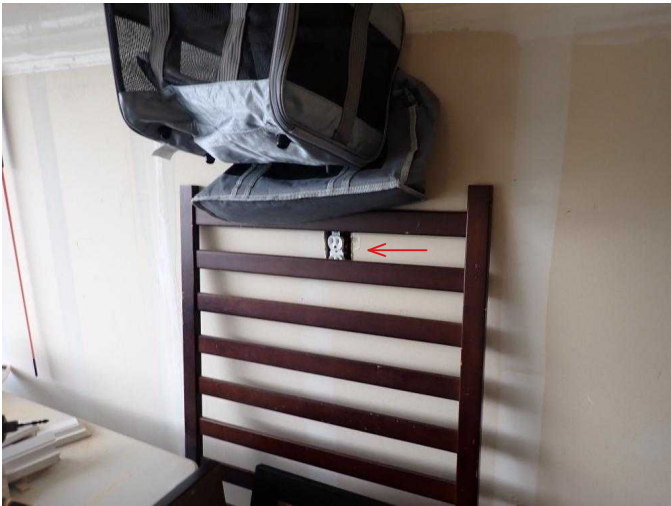
#61 W cover plate missing in garage, should be replaced.

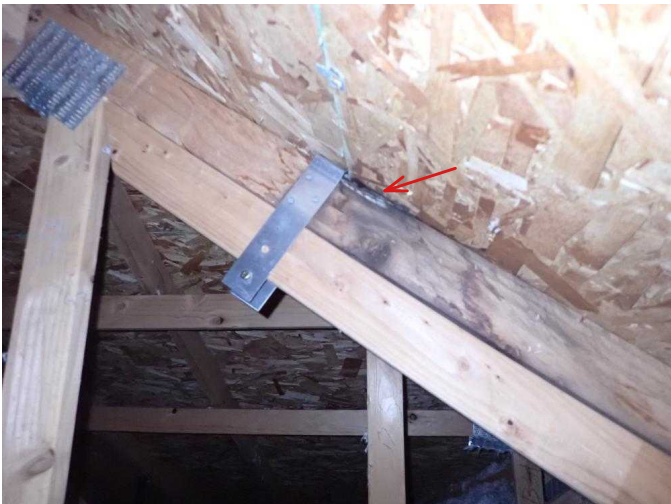
#63 Minor rot and staining in 2X4 truss system and sheathing material at NE safety anchor, visible in attic.

1. Method of Inspection: In the attic.
2. ☒ ☐ ☐ ☐ ☐ Access: Open.
3. ☒ ☐ ☐ ☐ ☐ Unable to Inspect: 0%
4. ☐ ☐ ☐ ☒ ☐ Roof Framing: 2x4 Truss. Minor rot in top of E 2x4 truss that NE roof safety anchor is attached to. Rot is from weather cover of NE safety anchor missing and minor water seepage into framing. Recommend qualified contractor evaluate and estimate repairs.

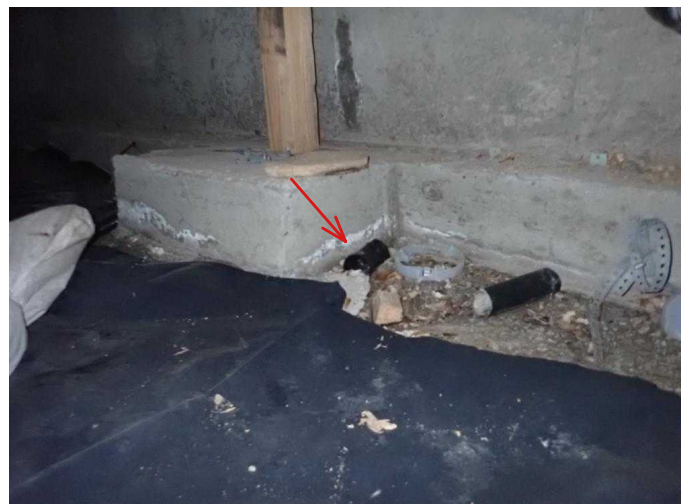
#66 All construction debris in crawl space should be removed.

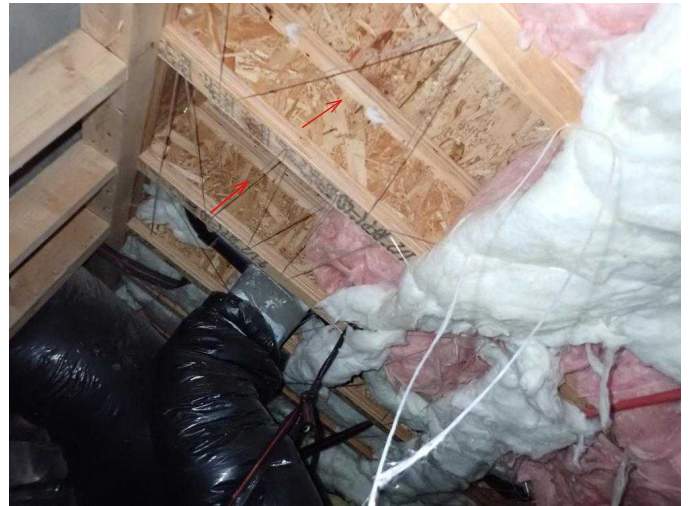
#68 Small sections of insulation missing from under pantry, reduced thermal efficiency.

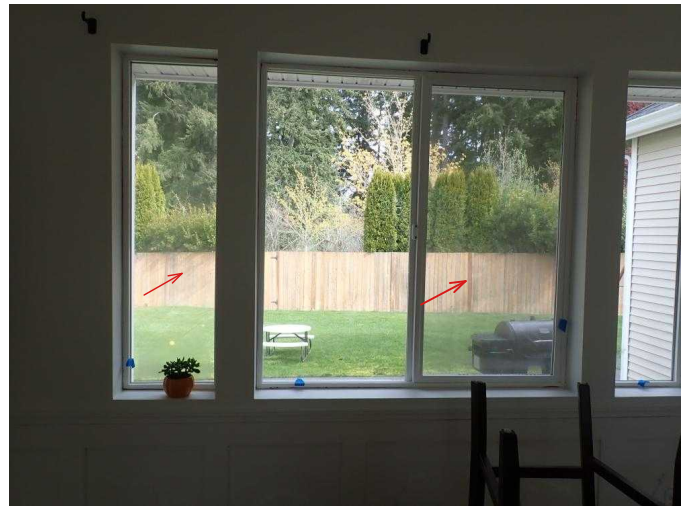
#70 Window seals are blown in dining room.

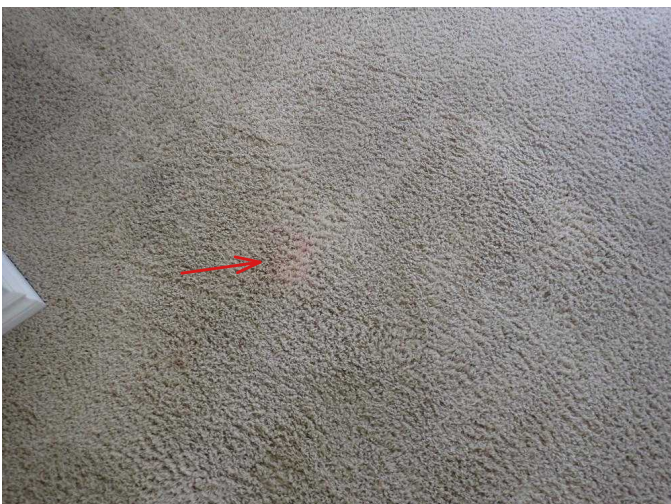
#71 Minor staining in first floor bedroom carpet.

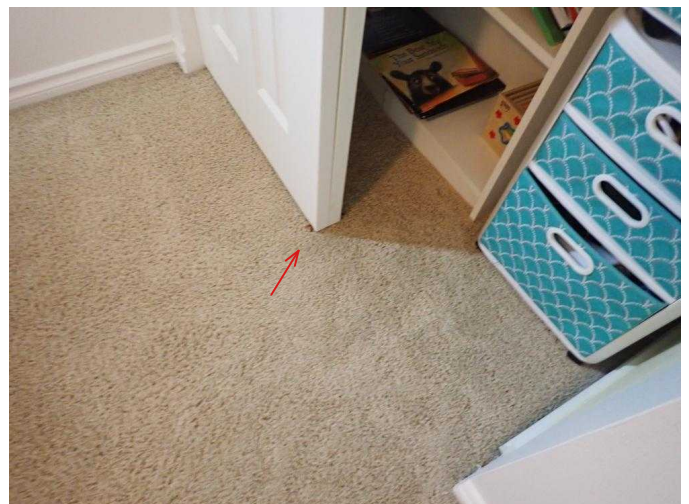
#72 Example of broken floor guides for bedroom closets.

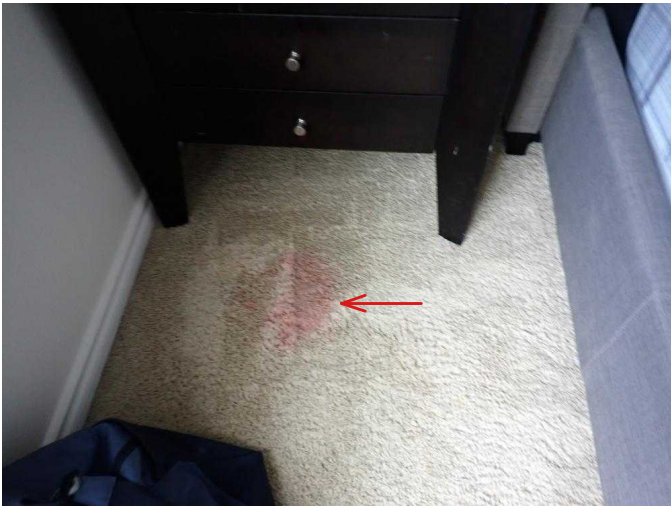
#73 Minor staining in N bedroom carpet.

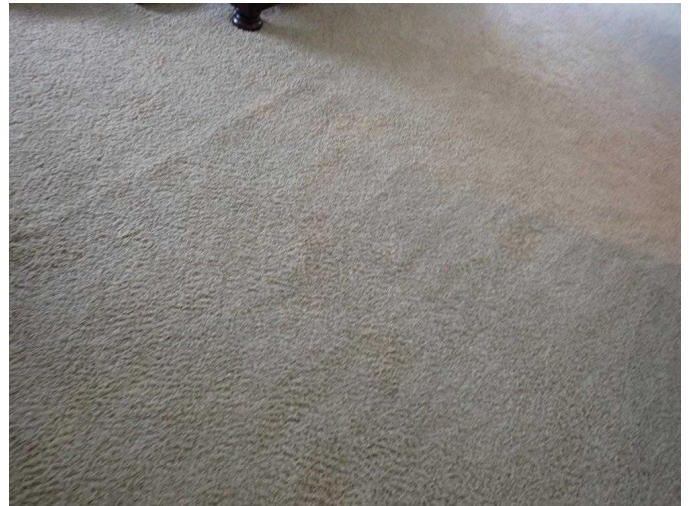
#74 Buckling present in master bedroom carpet.

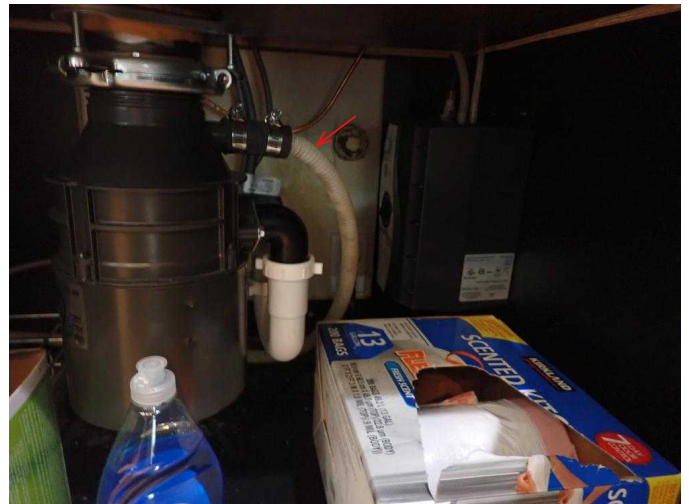
#76 No air gap or high loop present for dishwasher.

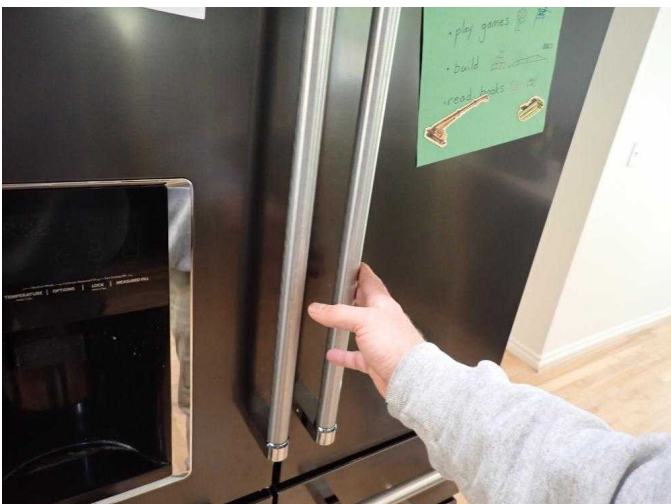
#77 Refridgerator handle loose on install.

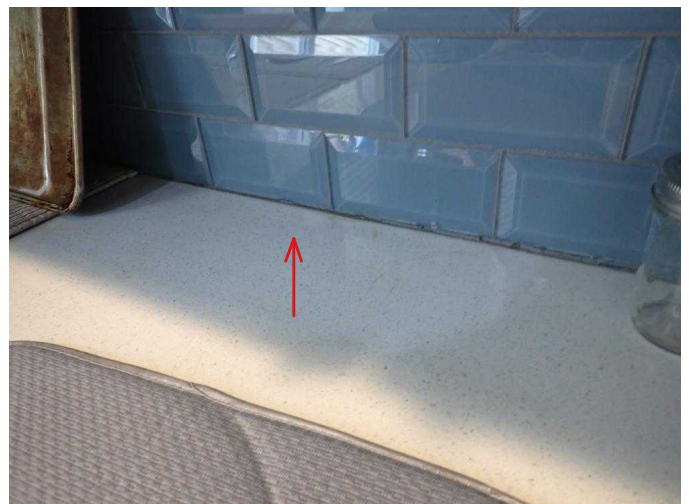
#78 Caulking at counter/back splash junction needs to be redone in kitchen.

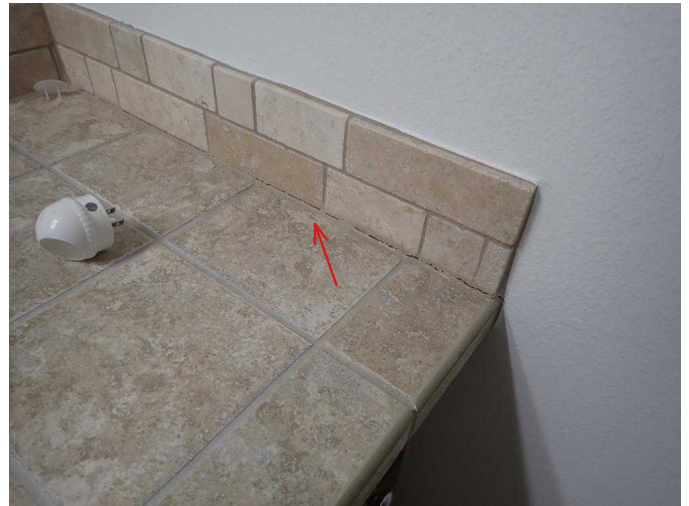
#80 Caulking needs to be redone at counter/back splash junction in second floor hall bathroom.

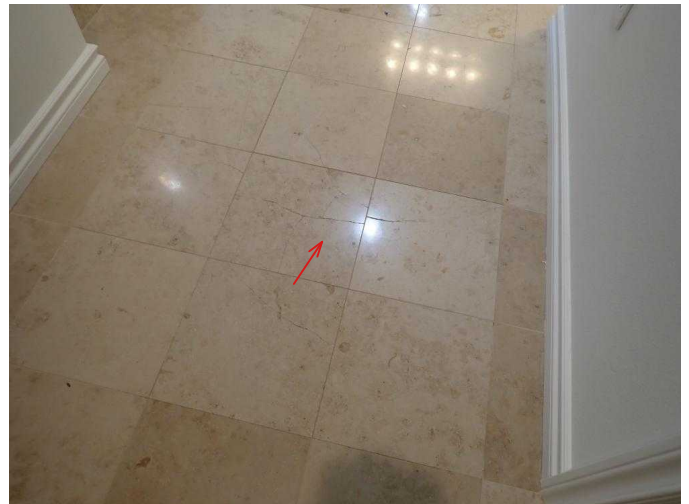
#82 Loose/cracked tiles in hallway into bathroom and in toilet closet in master bathroom.

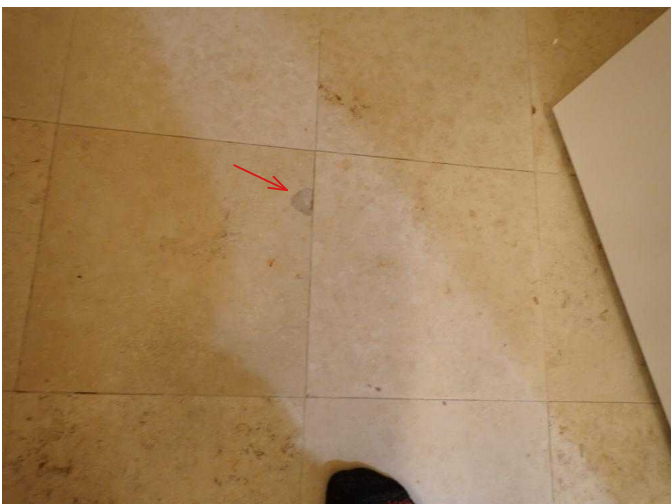
#83 Moderate chip in tile in master bathroom toilet room.

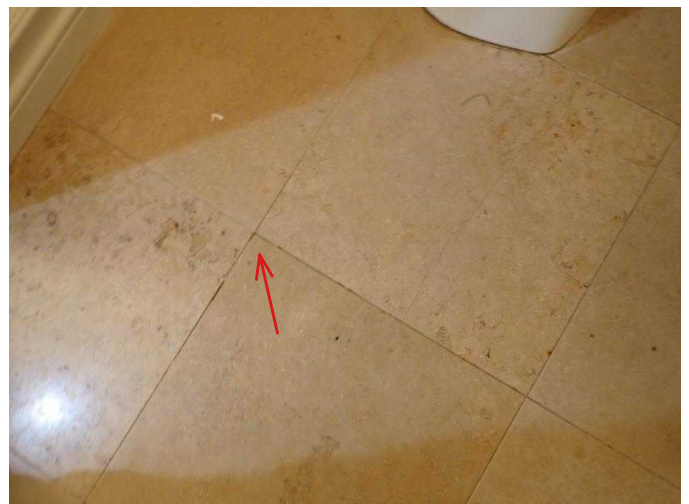
#84 Sections of grout missing in front of toilet in master bathroom.

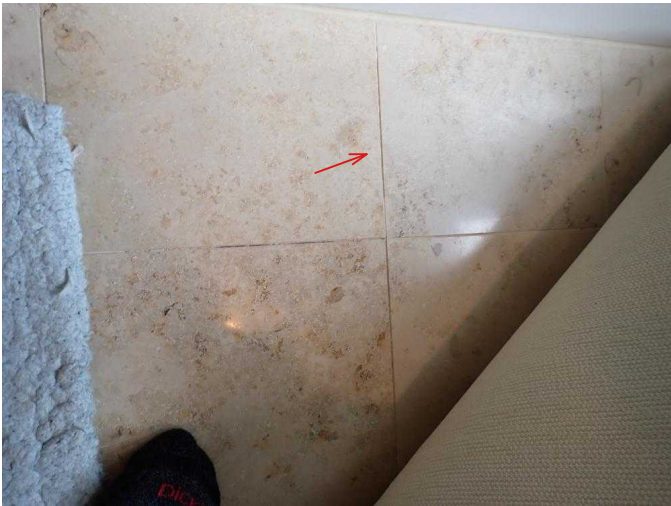
#85 Sections of grout missing in front of shower in master bathroom.

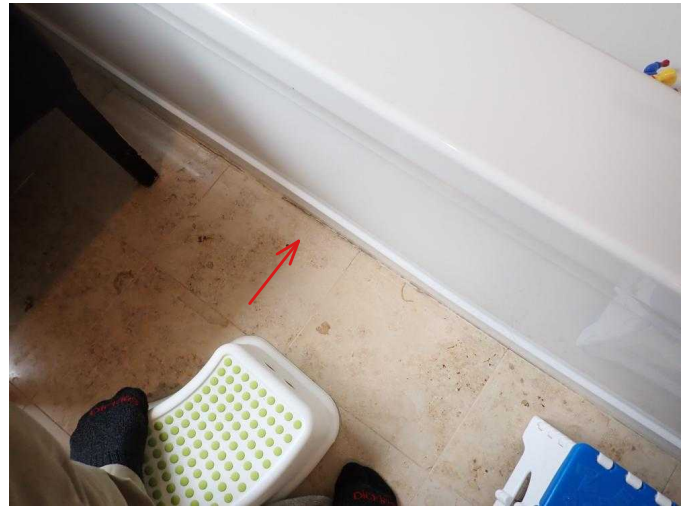
#86 Caulking needs to be redone at floor/tub junction in master bathroom.

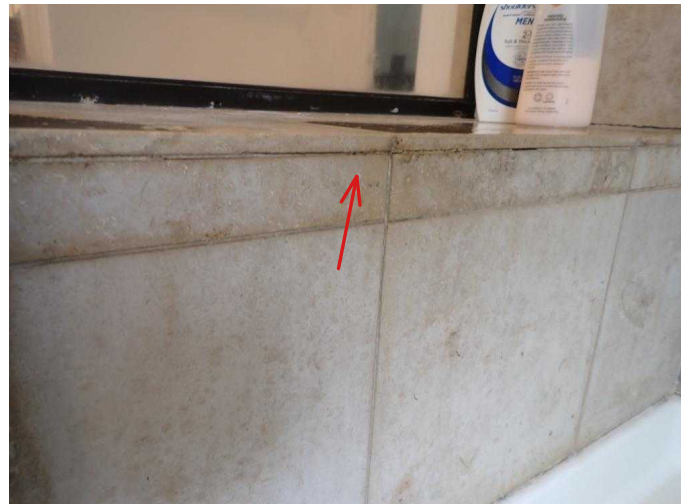
#88 Small sections in grout missing in front edge of shower seat in master bathroom.

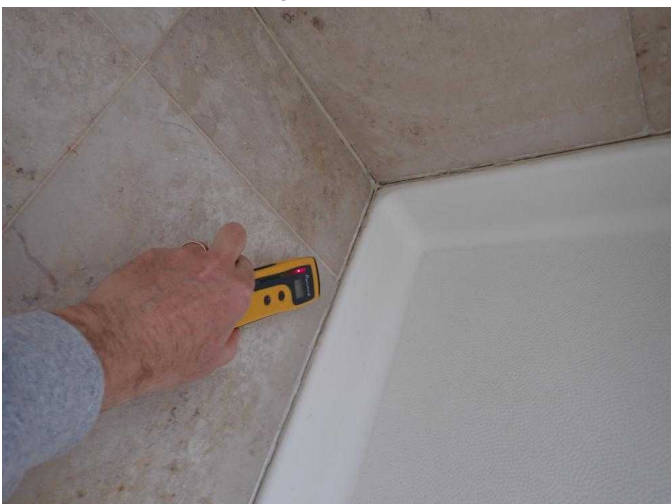
#89 High moisture reading in lower row of tile surround.

37. ☐☐☐☒☐ **Shower/Surround:** Tile. Small sections in grout missing in front edge of shower seat, water intrusion spots, need to be sealed.
High moisture reading in lower row of tile surround and under missing grout in shower seat, hidden conditions may be present.
Caulking needs to be redone at pan/surround junction.
All tile should be sealed.
Recommend qualified contractor evaluate and estimate repairs.

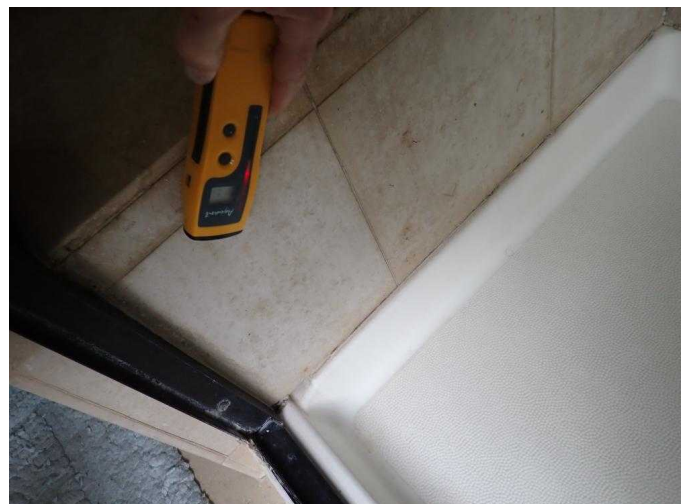
#90 High moisture reading tile under shower seat.

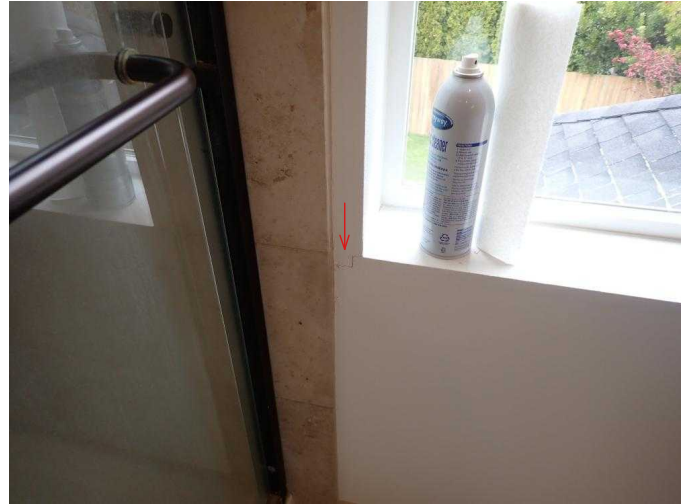
#92 Cosmetic crack in wall material next to master shower.
