V.I. Inspections

1813 72nd Ct SE

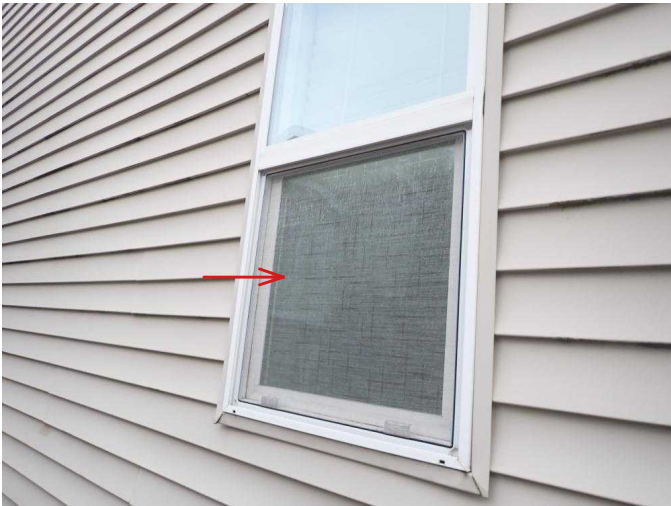
#7 Some screens are well weathered.

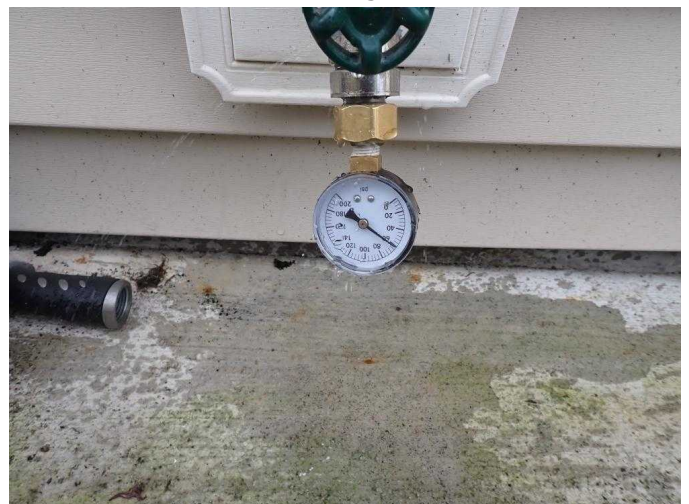
#12 Water pressure tested at 60 psi.

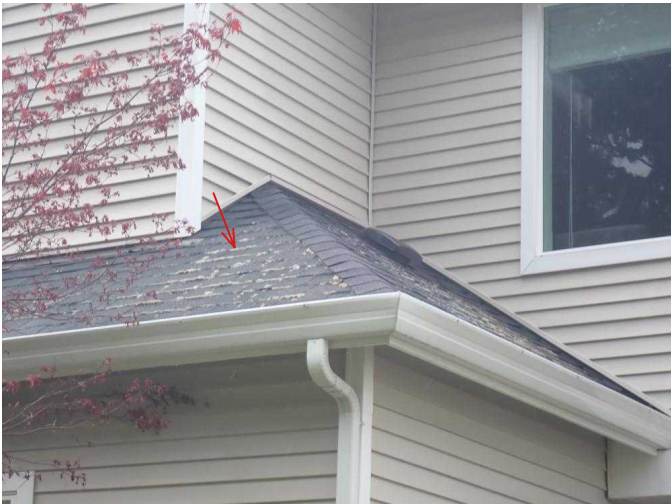
#13 Moderate moss build up on roof, moss appears to have been treated.

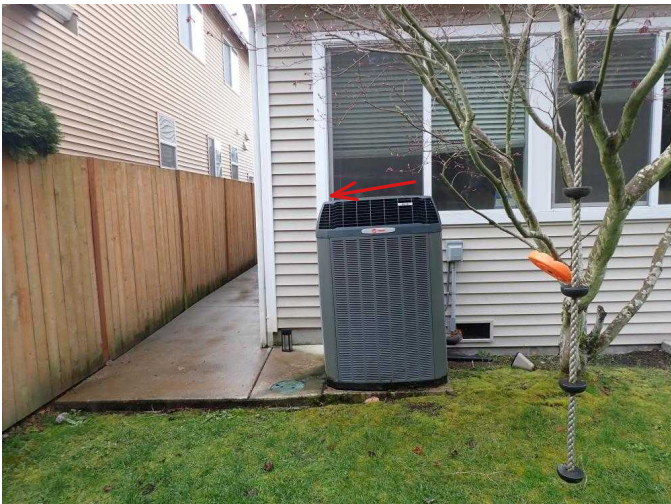
#15 Support pad for heat pump exterior unit is not level, exterior unit needs to be level to reduce stress load on

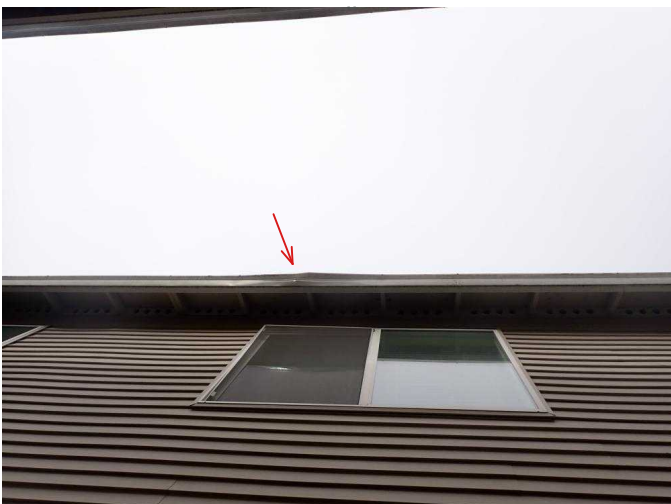
#17 Moderate dent in E gutter system.

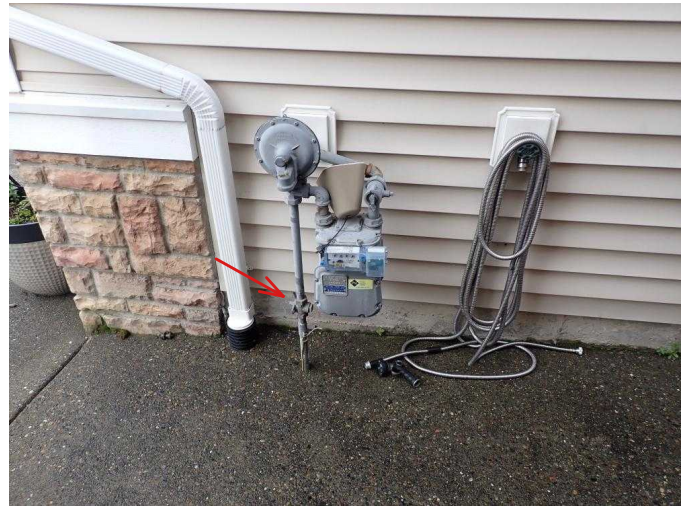
#20 Gas main shut off valve at meter located on the E side of the house.

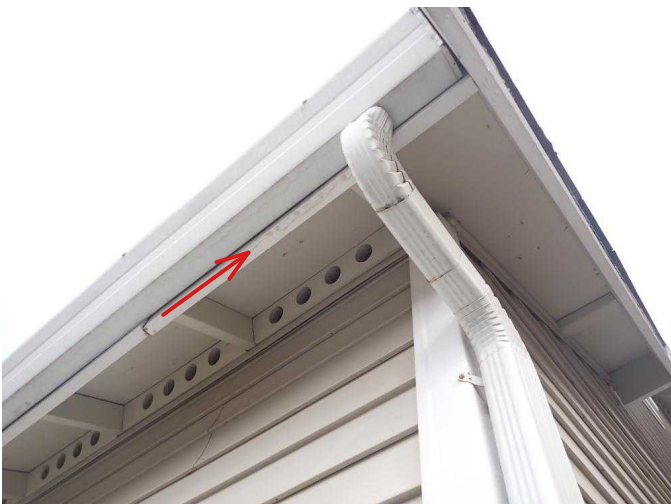
#23 Water behind E end of attached garage gutter indicates roof water is getting between gutter and garage fascia board.

4. Type: Combination.
5. Approximate Age: 15-20 years.
6. ☐ ☐ ☐ ☒ ☐ Flashing: Stamped metal. Active water drip leak behind E end of attached garage gutter system indicates roof water is getting between gutter and garage fascia board.
A qualified roofing contractor is recommended to evaluate and adjust drip edge flashing.

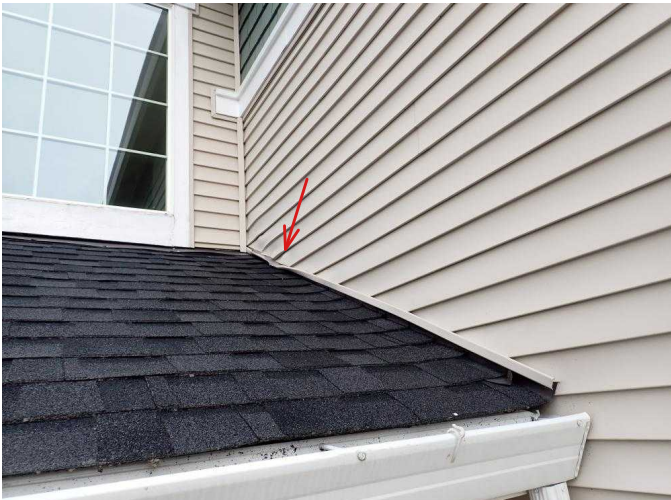
#25 Lower vinyl J-track on E side of front porch door is bent.

1. ☒☐☐☐☐ **Type:** Vinyl siding, Stone veneer. Lower vinyl J-track on E side of front porch door is bent.
Minor buckling in lower E siding.
Recommend qualified contractor evaluate and estimate repairs.

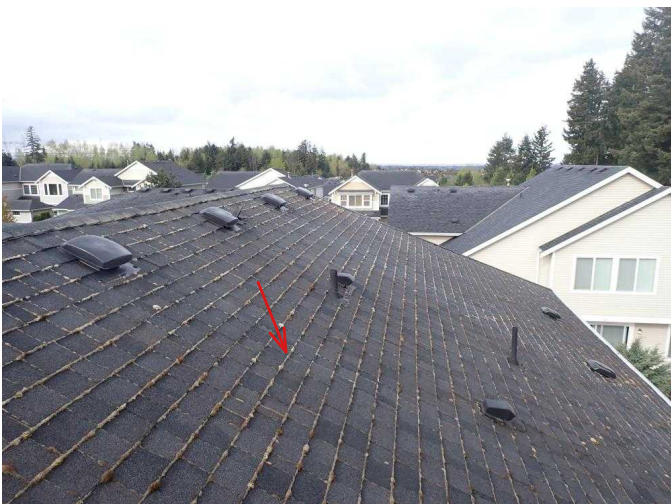
#35 Moss build up on roof.

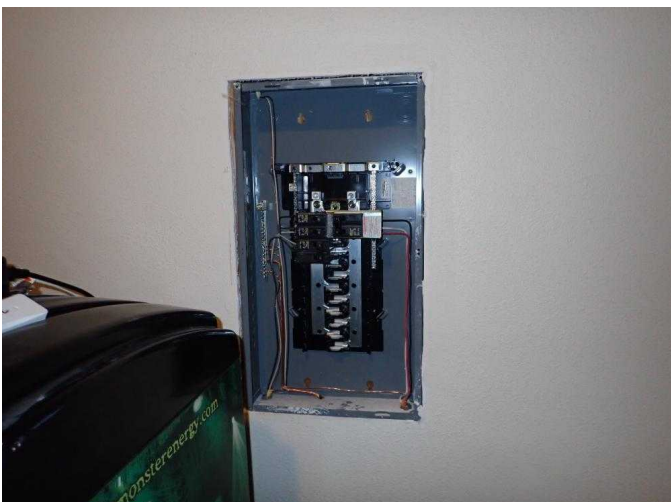
#47 Secondary electric panel located in detached garage.

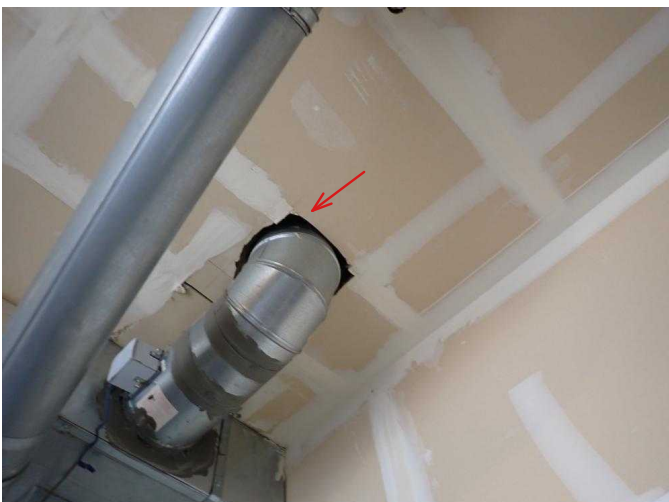
#59 All open holes and gaps in ceiling need to be sealed against fire intrusion if a vehicle is to be parked in the garage.

19. ☒☐☐☐☐ Service Doors: Metal. Garage service door handle sticks when engaged and is loose on install, needs adjustment.
20. ☐☐☐☒☐ Ceiling: Fire taped. All open holes and gaps need to be sealed against fire intrusion if a vehicle is to be parked in the garage.

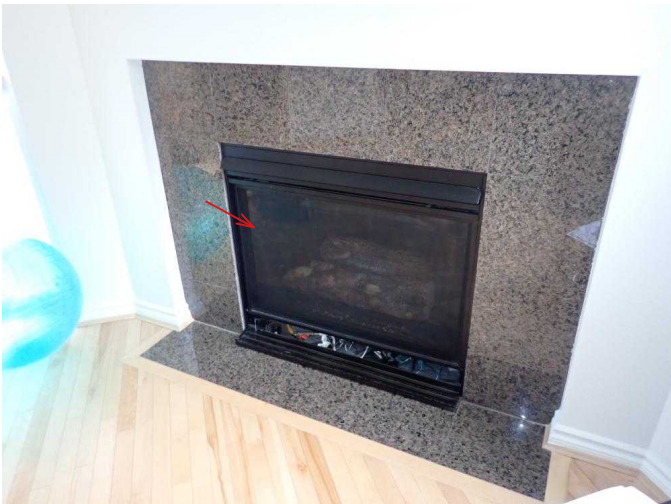
#75 Glass needs cleaning. Only use gas fireplace glass cleaner.

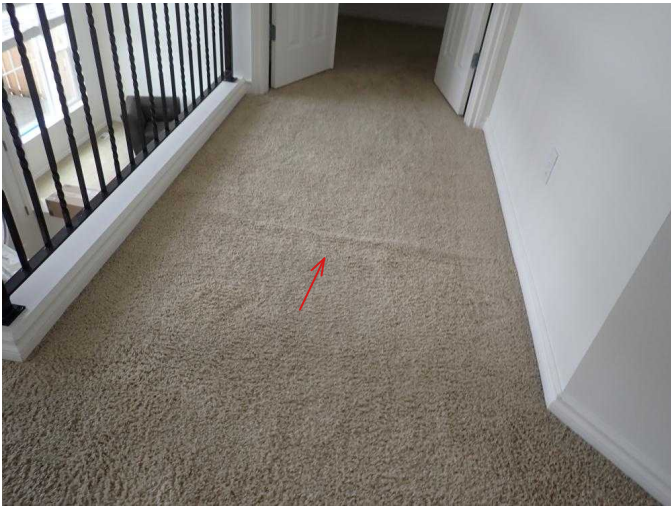
#79 Minor buckling in second floor hallway carpet. (added)

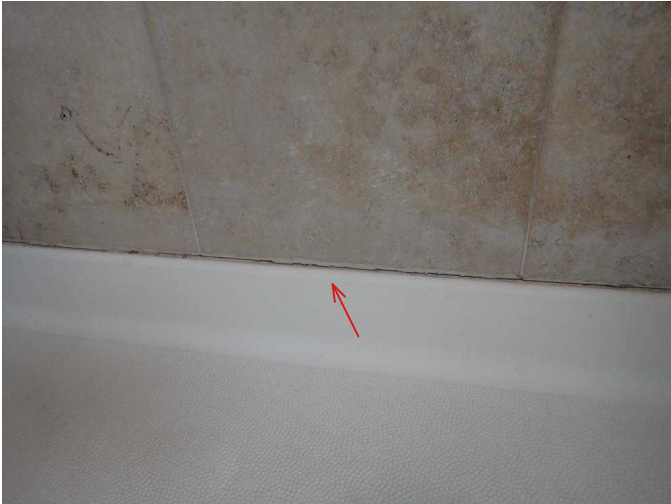
#91 Caulking needs to be redone at pan/surround junction in master bathroom shower.
